Papua, Indonesia

FLASH FLOODS

Affected Area	Papua Province, Indonesia (located in Island of New Guinea) Sentani, Jayapura Regency in northern Papua	Death toll*	112
Date of Occurrence	March 16, 2019	Missing*	17
Outline	Heavy rainfall of 235mm in 8 hours caused a landslide in the mountains north of Lake Sentani, which blocked the headwater of a river and formed a natural dam. It burst eventually resulting in the deadly flash floods.

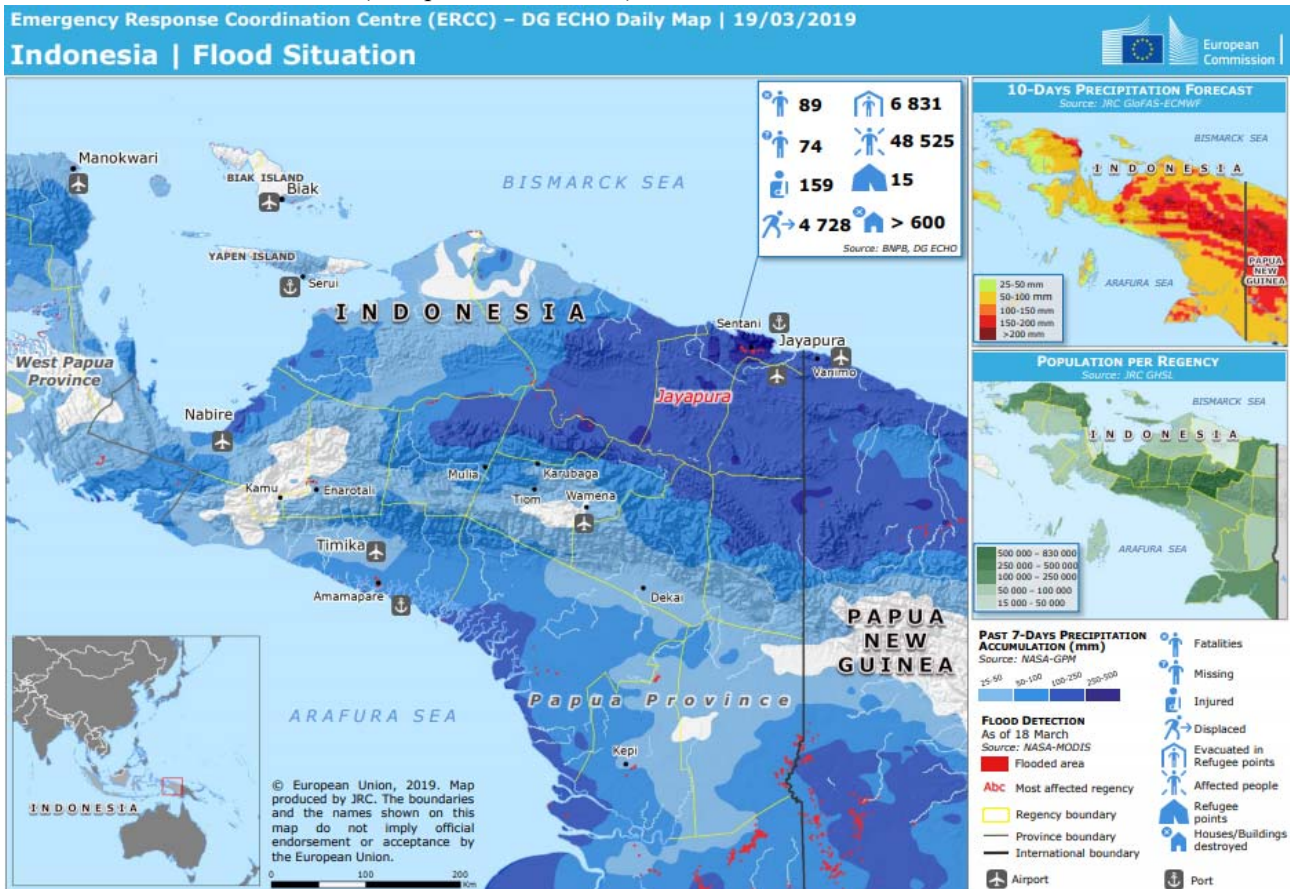
Flood Situation as of March 19 (European Commission)

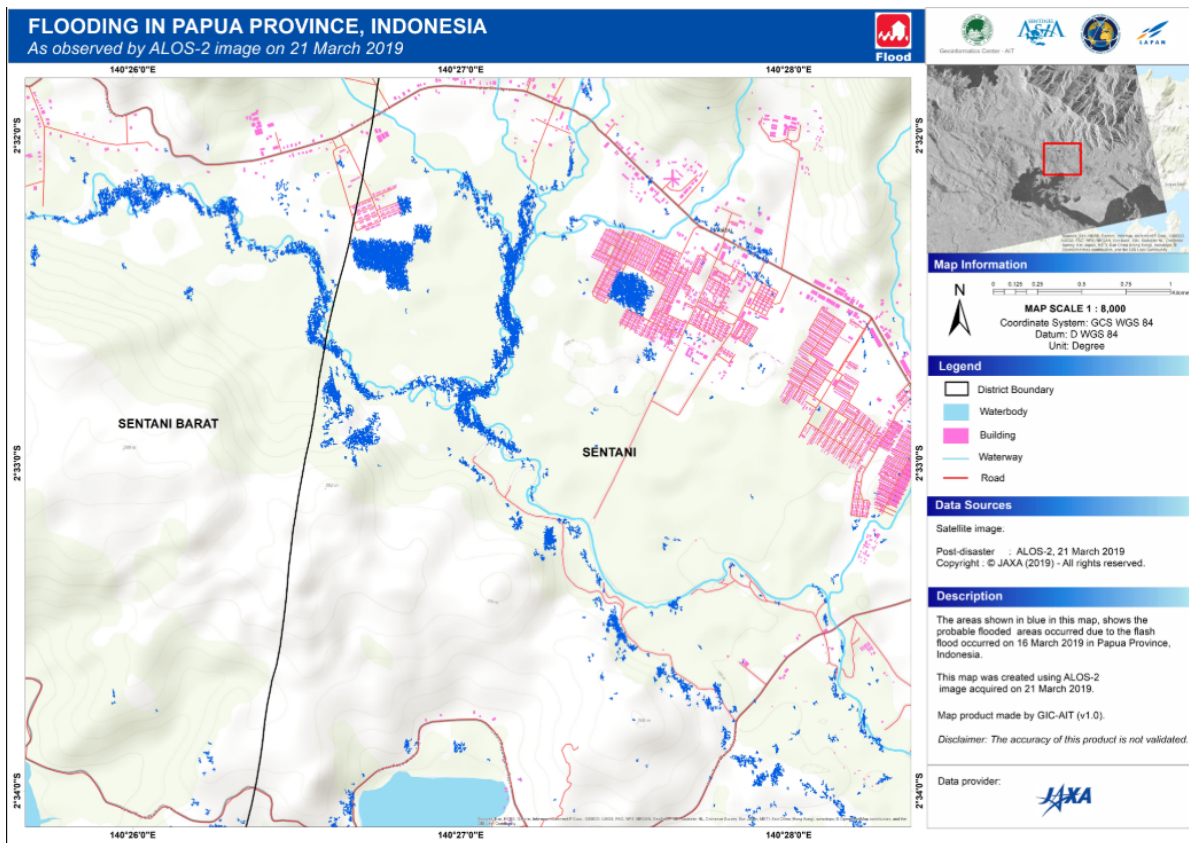
Flooding in Sentani (#1) as observed by satellite on March 21 (JAXA)

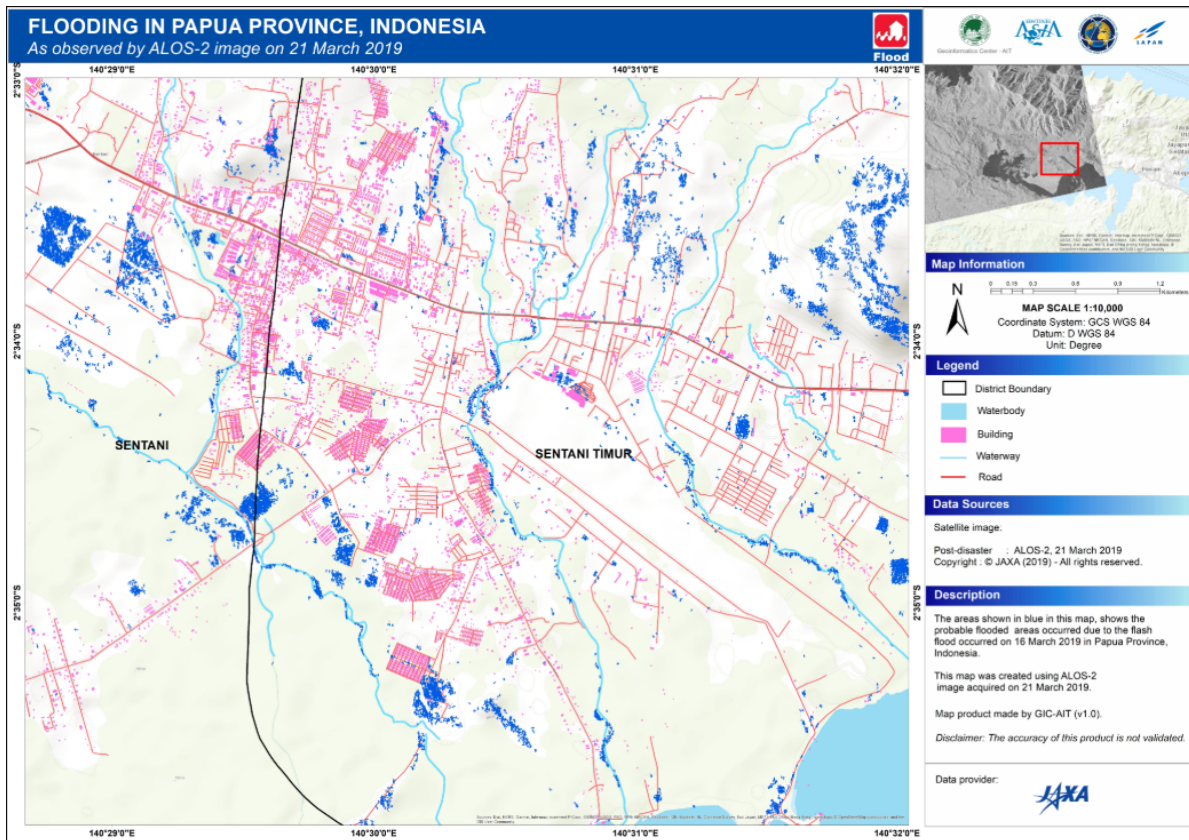
Flooding in Sentani (#2) as observed by satellite on March 21 (JAXA)

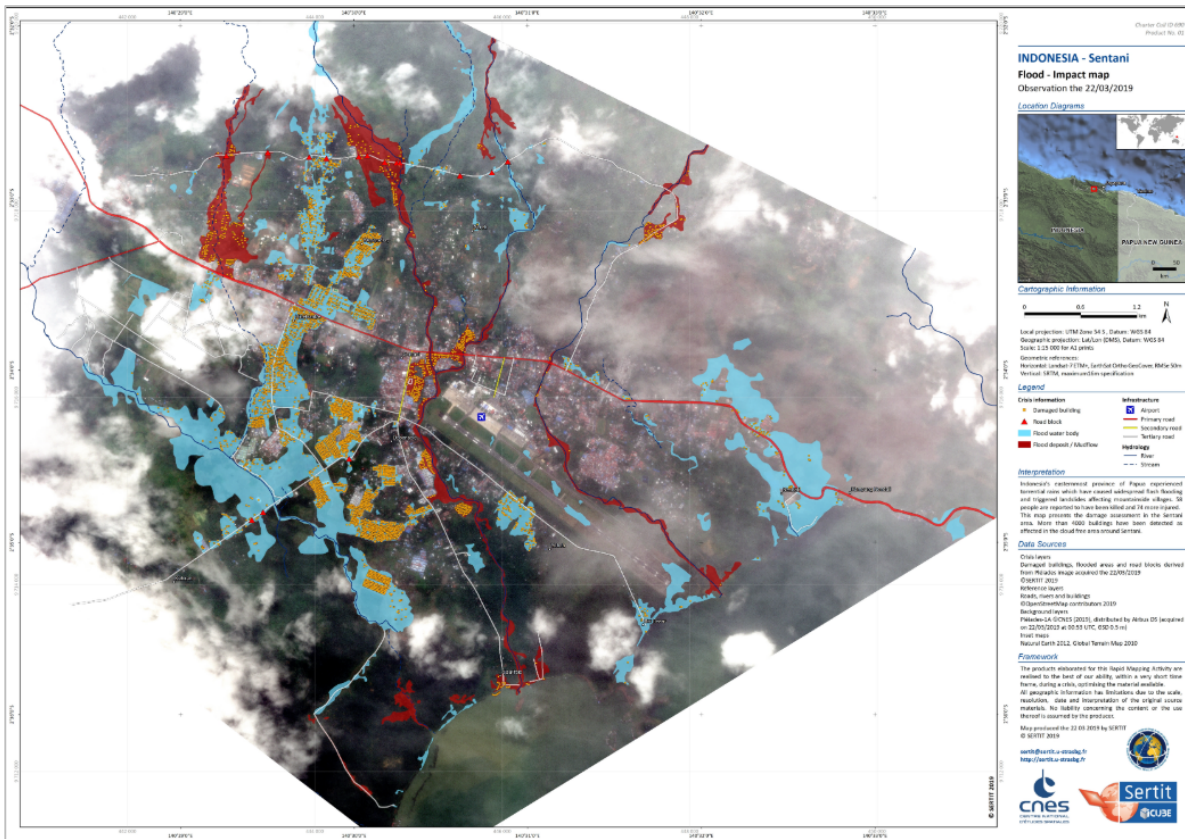
Flood Impact in Sentani (SERTIT)
